Structures Technical Memorandum 370

EVALUATION OF A VIBRATION TECHNIQUE FOR DETECTION  
OF BARELY-VISIBLE IMPACT-DAMAGE IN COMPOSITES.

R. JONES and A. GOLDMAN

A vibration analysis technique has been used for non-destructive evaluation of the integrity of fibre composite components which contain barely-visual impact-damage. A description of the method and the associated problems is presented together with the results of laboratory tests.

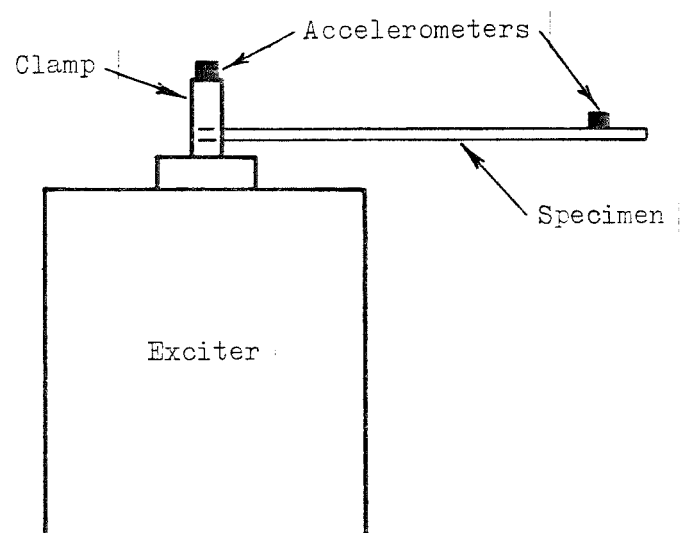
FIG.1 CONFIGURATION OF TEST RIG

The specimens were supported in a clamp mounted on an electromagnetic shaker. Fig. 1 shows the general configuration of the test rig.

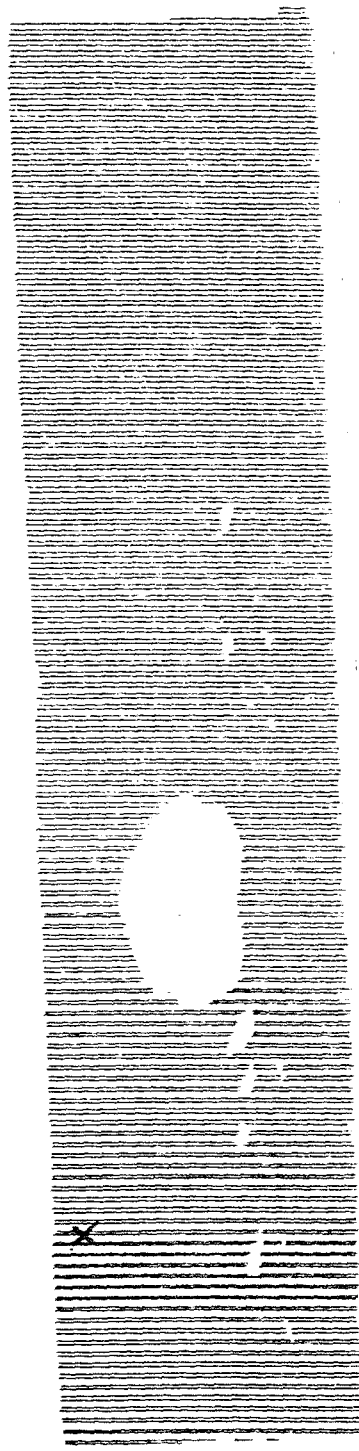
FIG.2 ULTRASONIC SCAN OF FIRST SPECIMEN - DAMAGED

For the first specimen, Figure 2 shows that a significant account of damage had been introduced close to the location of the accelerometer. In Figure 3 it can be seen that changes in frequency have occurred around 1800 hertz and 5000 hertz. Both changes are approximately 2 percent. reductions.

X = Location of accelerometer

Figs. 2, 4 and 6 show the results of the ultrasonic scans on two specimens, and Figs. 3, 5 and 7 show the corresponding vibration test results.

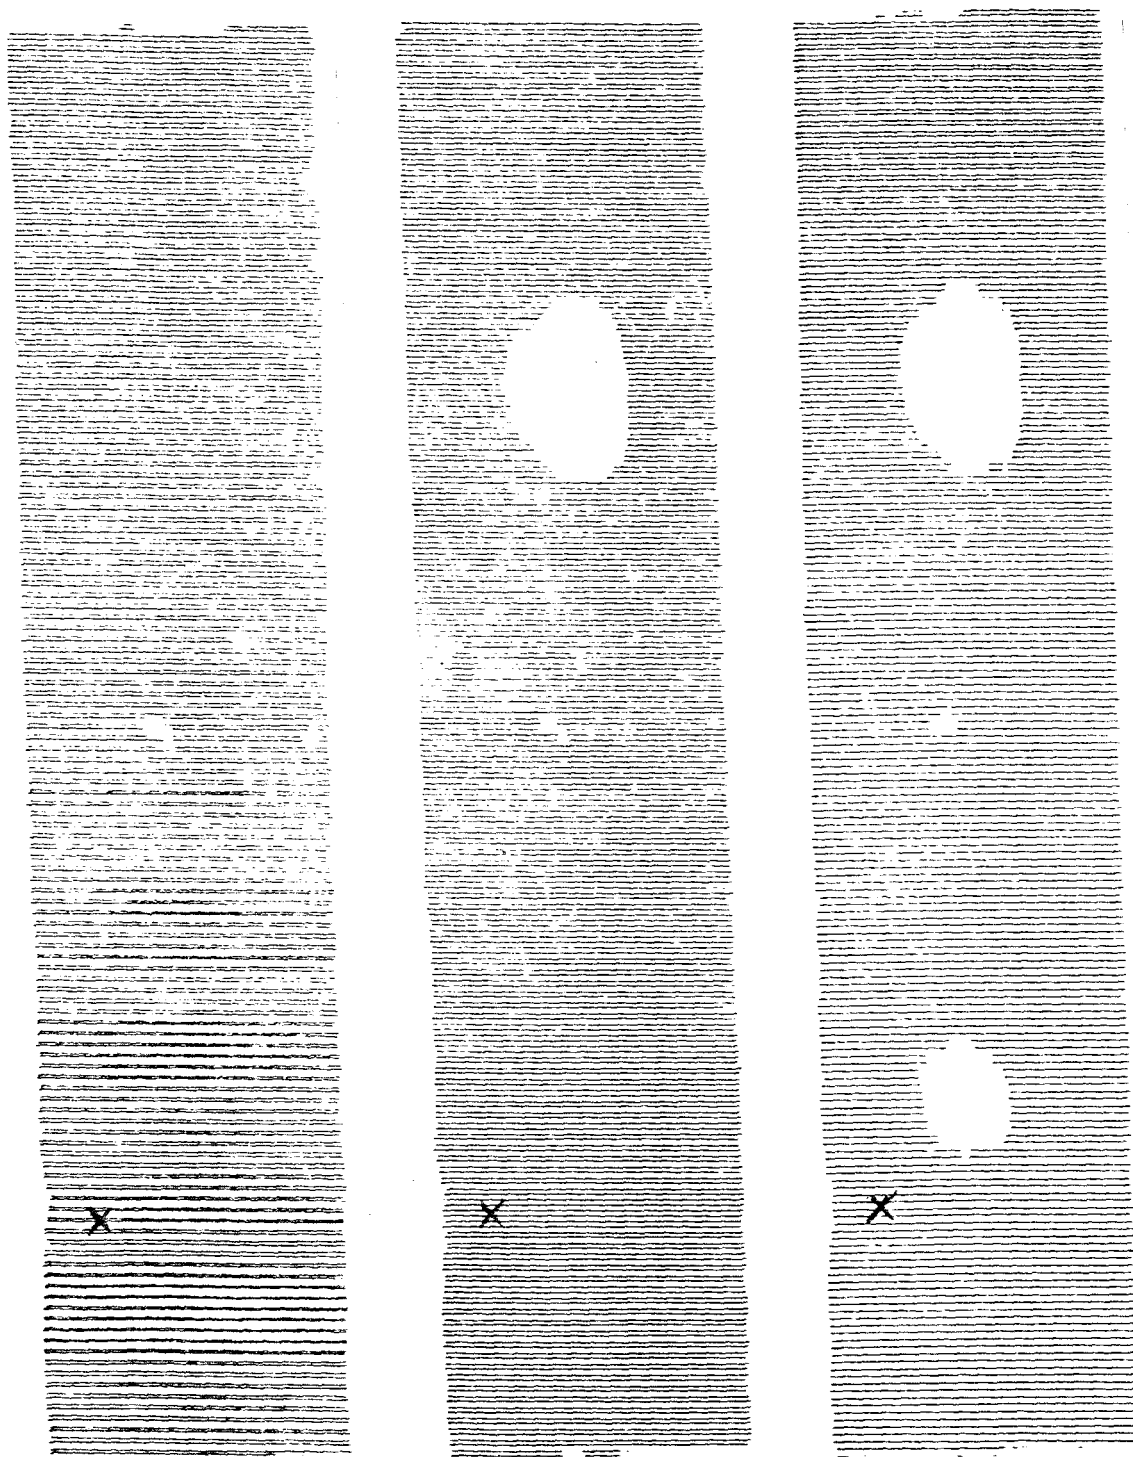
FIG.4 ULTRASONIC SCAN OF SECOND SPECIMEN - UNDAAGED & DAMAGED

The second specimen was subjected to increasing amounts of damage. Figure 4 shows the two stages of damage and Figure 5 indicates that there were no detectable changes in frequency of any of the modes of vibration observed in the 1000 - 6000 hertz range. The changes in amplitude are believed to be due to slight changes in the position of the accelerometer.

Undamaged

1st Stage damage

2nd Stage damage

The inability of the method to detect the damage shown in Figure 4 may be due to the damage being of insignificant level, or that the accelerometer was placed too far from the damage, or on a nodal line of the significant mode. Further work is necessary to answer these questions.

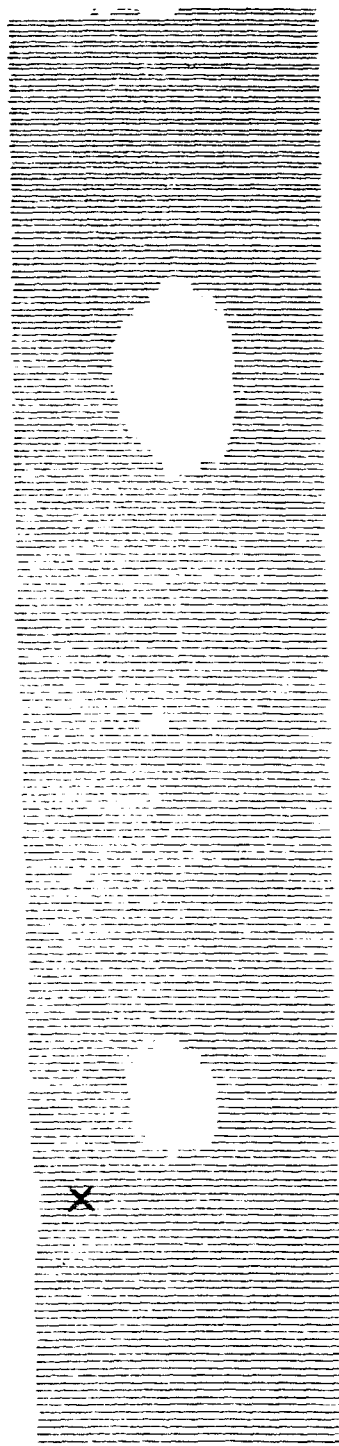
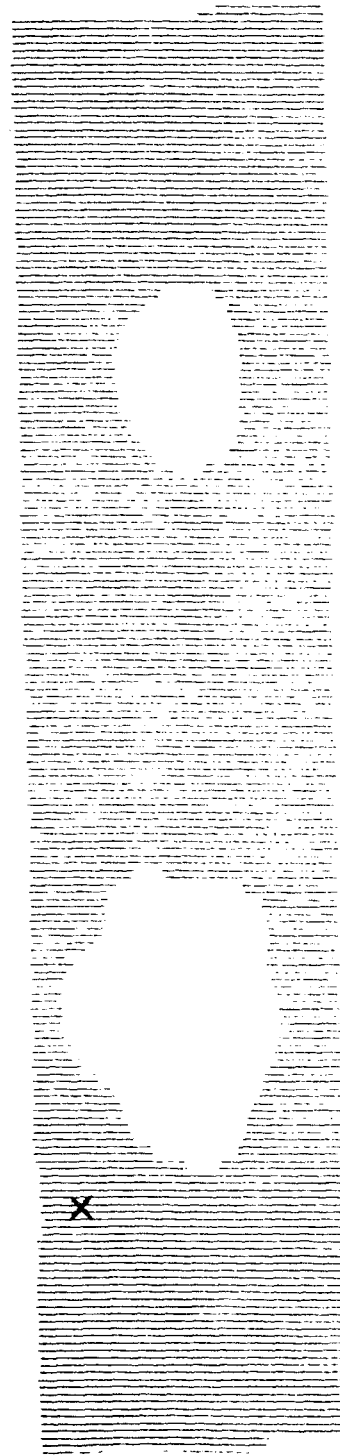
FIG.6 ULTRASONIC SCAN OF SECOND SPECIMEN - FURTHER DAMAGED

Further damage was introduced to this second specimen, as indicated in Figure 6, which brought about significant changes in frequency at 2100, 3500, and in the 5000 - 6000 hertz range.

Original

Further damaged

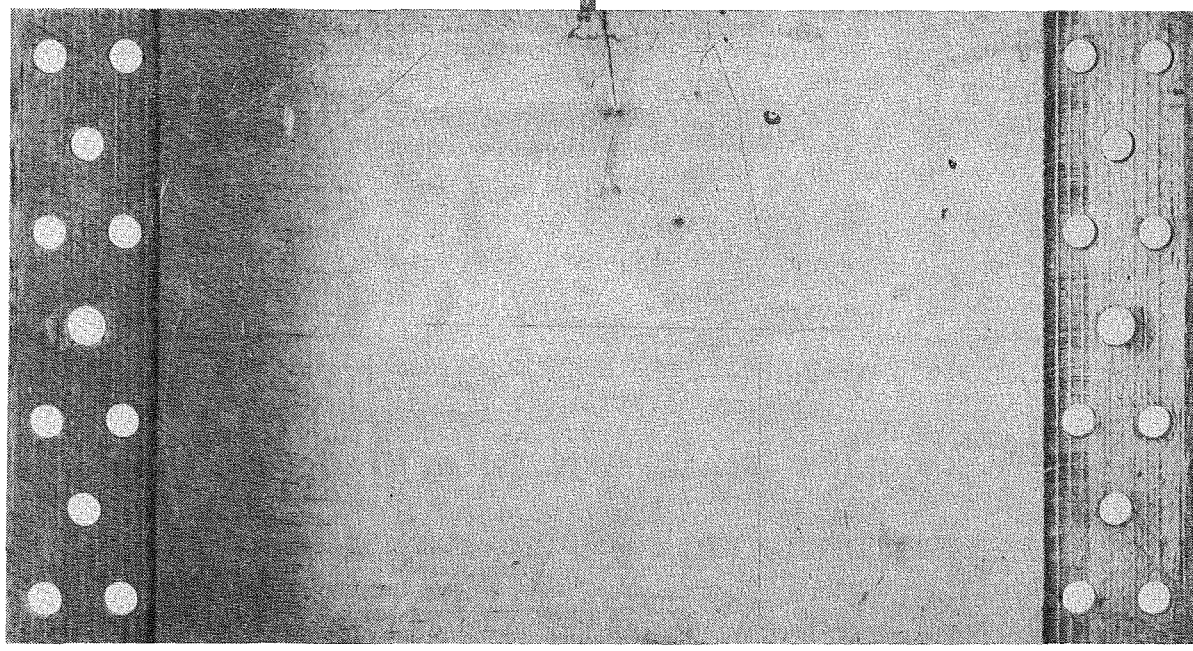
FIG. 8a ALUMINIUM ALLOY PANEL WITH CRACK

The ability to detect the presence of delamination damage in graphite-epoxy laminate specimens led to the investigation of whether the same method could be used to detect delaminations in bonded boron-fibre repairs to cracked metallic wing skins. This repair scheme has been pioneered by the Aeronautical Research Laboratories, Australia, and is now widely used to repair cracks in aircraft in service with the RAAF. Examples include skin cracks in the lower wing surface of Mirage III aircraft, stress corrosion cracking in Hercules wing planks, and cracks in the console truss in F-111. A detailed discussion of the current state of crack-patching technology is given in Ref. 3 and 4. In this scheme, cracked metallic components are repaired by bonding uni-directional boron-epoxy laminate over the crack with the fibres lying perpendicular to the crack. A typical repair to a cracked aluminium panel can be seen in Figure 8.

A detailed three dimensional finite element model of the panel shown in Figure 8 was developed by the author as part of a joint Australian/U.S./Canadian co-operative program on repair technology.
